Fort Howell Management Plan

Hilton Head Island Land Trust

January 2021

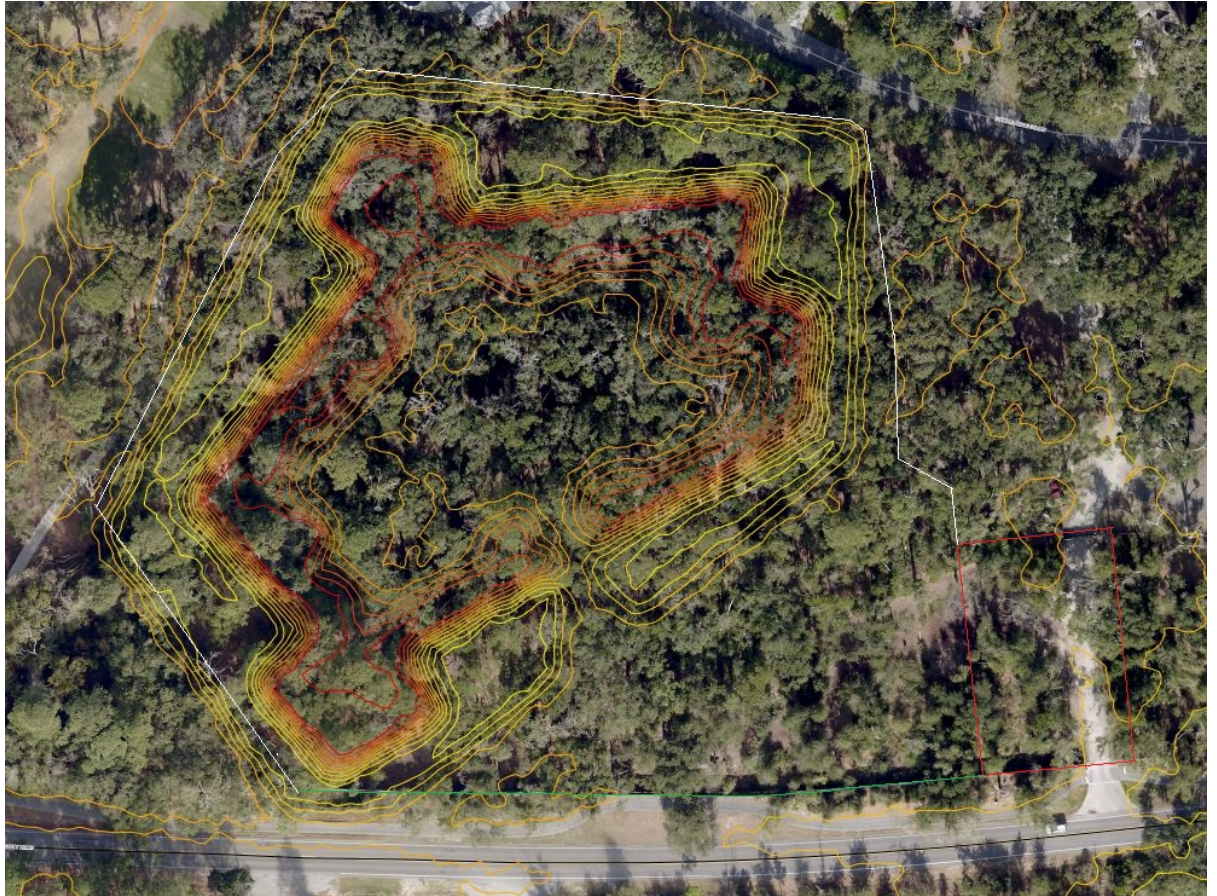
Topographic Map of Fort Howell

Map 1. The white line marks chain link fence and approximate property line with Palmetto Hall. The green line marks 8-foot-high barrier fence along Beach City Rd. The area in red is the access to the site used under an easement from Palmetto Hall. Trees and understory vegetation cover the entire site.

Today it is completely covered with vegetation consisting of oak trees, sweet gum, pine trees, blueberries, green briars, palmettoes, and various other underbrush (See Map 1 in the Appendix). The tree canopy and understory have allowed the fort to be so well preserved for these 155 years. The vegetative cover must be managed in a strategic way, especially where it exists on the earthworks and ditch.

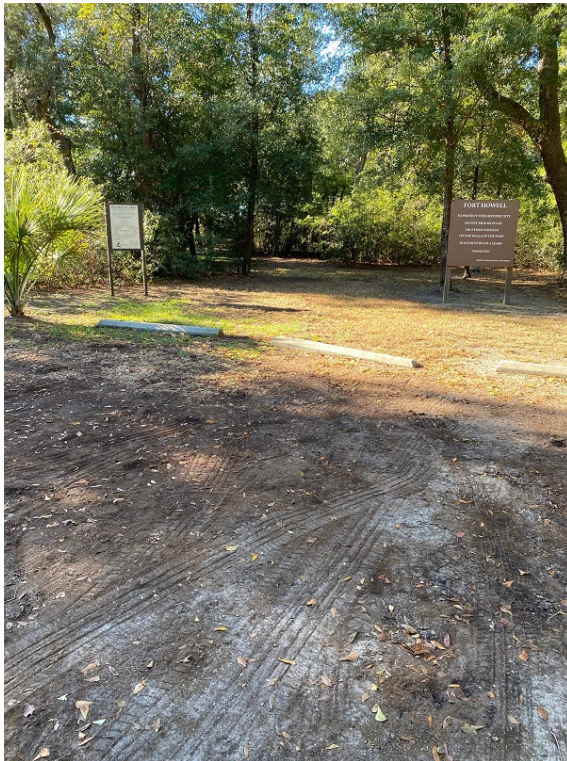
3.3 Parking - The parking lot is a small unpaved lot with spaces for 8 automobiles and a bicycle rack that can hold 8 bikes. School or tour busses can drive into the parking lot but must back up to turn around before leaving the site. The lot is accessible directly from Beach City Road. The surface of the parking lot is comprised of fine mulch and soft sandy soil that becomes muddy and rutted after it rains. (See Photo 2 in the Appendix). The lot is too small, especially when tours are present, and needs a competent permeable base to support vehicles regardless of the weather.

Photo 2. Parking lot surface and start of path to Fort from the parking lot.

4.3.1 Parking - The parking lot needs to be expanded to better accommodate cars and busses. A more solid base needs to be installed to prevent erosion of the lot itself. An application was submitted to the TOHHI for an ATAX grant and approved for additional improvements to the site. The principal request is to upgrade and improve the parking lot to better accommodate vehicles used by visitors who come to the site.

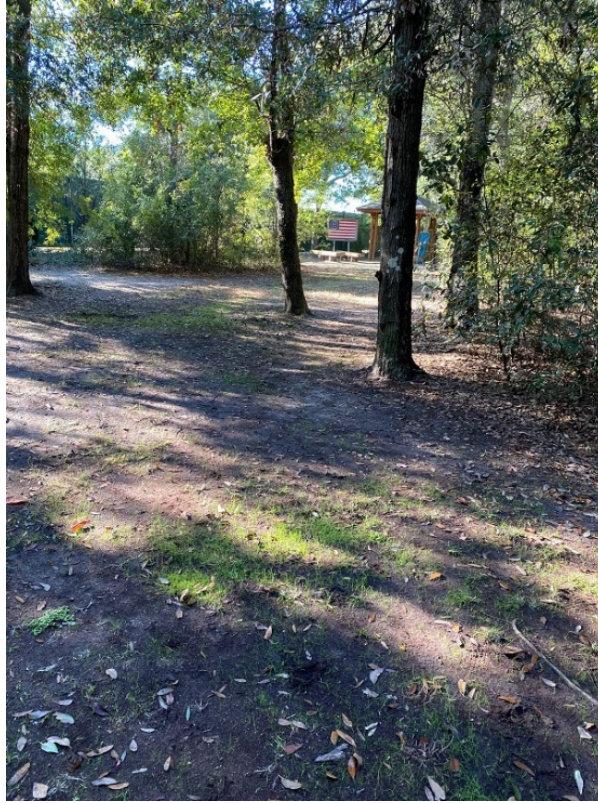
3.4.1 A path leads from the Parking lot to the informational kiosk (Photos 3 and 4). This path is surfaced with some grass and bare soil that becomes soft and somewhat muddy after rain. At a narrow point along the path an optical scanner has been installed to keep count of the number of visitors.

Photo 3. Path from parking lot to flag and kiosk.

4.3.2 Pathways - The path from the parking lot to the informational kiosk, as well as from the kiosk to the entrance to the fort, should be clearly defined and stabilized to support foot traffic and occasional maintenance vehicle traffic, without causing damage to the existing soils. This would require treatment similar to the parking lot but would not have to be able to support as much or as heavy vehicle traffic. The extension of the path from the bridge to the North Bastion needs to be stabilized to avoid potential erosion where bare soil is exposed. Coarse mulch, such as bark chips, could be placed on the path to reduce or eliminate wear on the original soil surface.

- 4.4.5 Path from Parking Lot to Kiosk – This path should be more clearly delineated and the surface stabilized. Funds for this work will be sought in 2021 for work to commence in 2022.

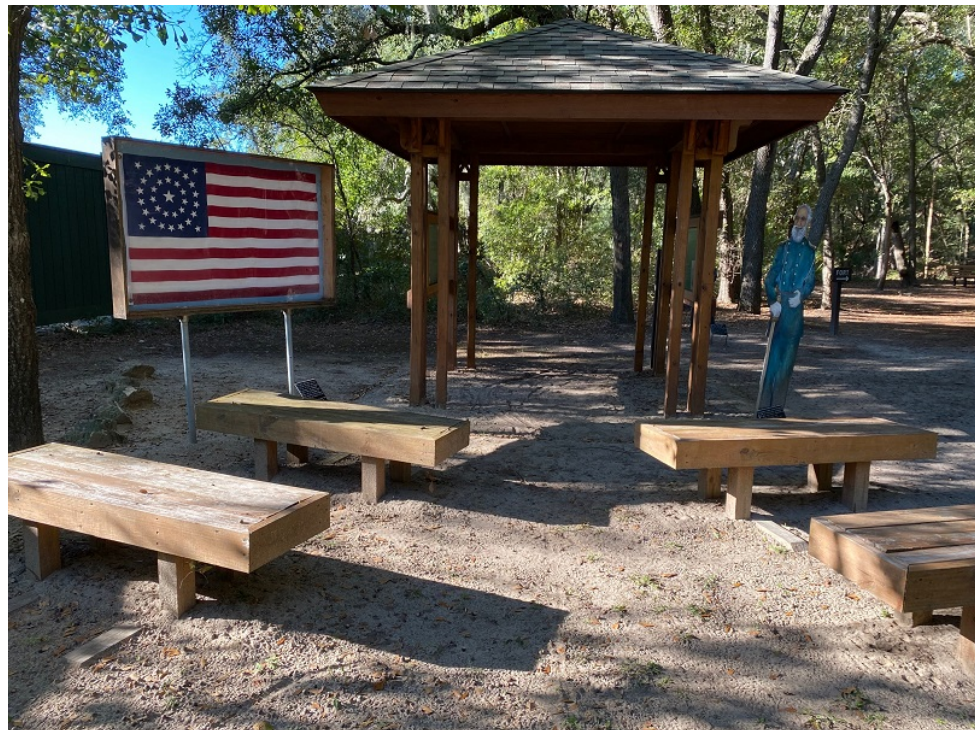
3.7.1 Informational Kiosk – Along the path from the parking lot to the entrance of the fort is a kiosk and four benches. The kiosk has placards that explain the history of the fort and its context. It is the focus of information and a setting for presentations about the fort and its history. There is also a display of a replica of the flag that would have flown over the fort at its time of completion.

Photo 4. Flag and information kiosk.

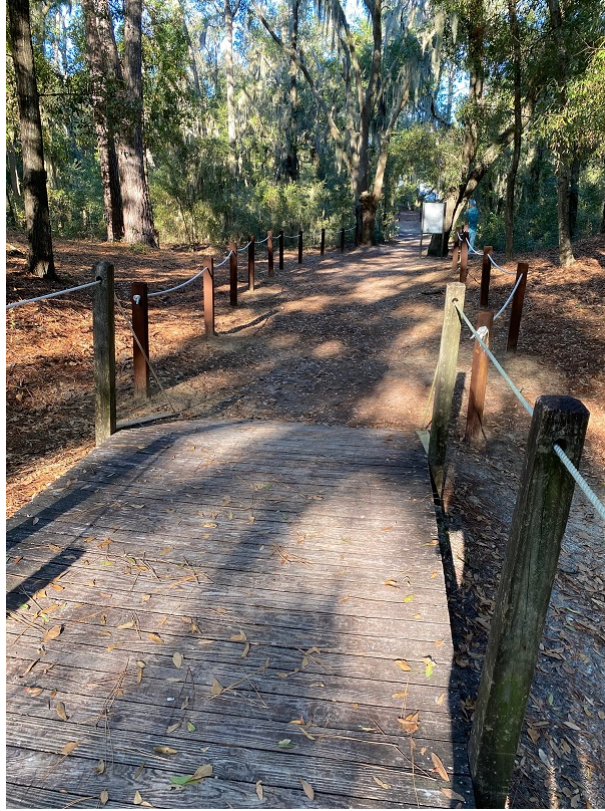
3.4.2 From the kiosk, there is a path that leads across a “bridge” that lies directly on fill across the ditch and thence into the fort interior and up a slope to the North Bastion (Photos 5 and 7). The surface is on the original floor of the fort interior and slope leading to the top of the wall. Much of this path has been worn down to bare soil. This path has ropes along a portion to discourage visitors from leaving the path and walk along the tops of the fort walls (Photo 5).

Rope fences have recently been added along the pathway between the entrance to the fort and the North (Photo 5). These have been added to try to better limit access by visitors to the tops of the walls and the Bastion itself.

Photo 5. Bridge over ditch and entrance to fort.

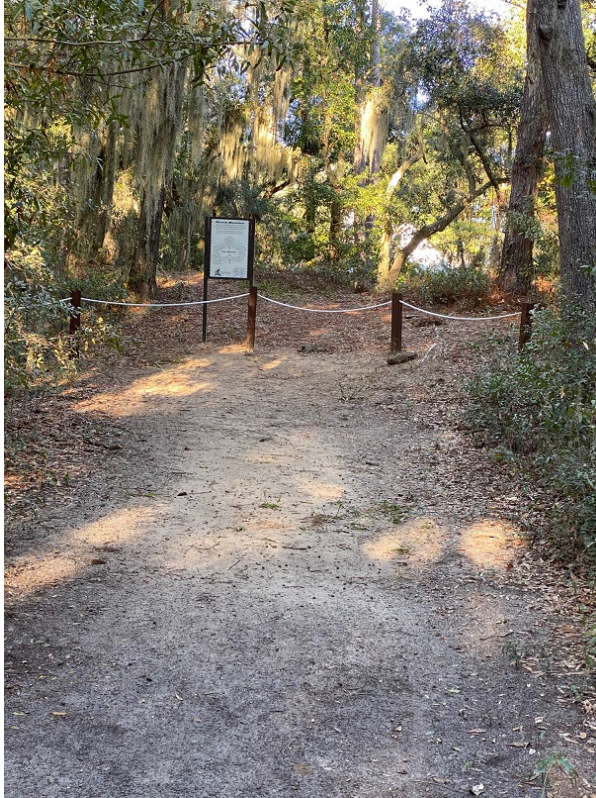
Photo 7. Continuation of entrance path to the North Bastion.

- 4.4.3 Path to the North Bastion – Coarse mulch should be placed on the path leading from the bridge to the North Bastion. This work could be done using any surplus funds from existing grants and done by volunteers. This work may be started as soon as 2021.

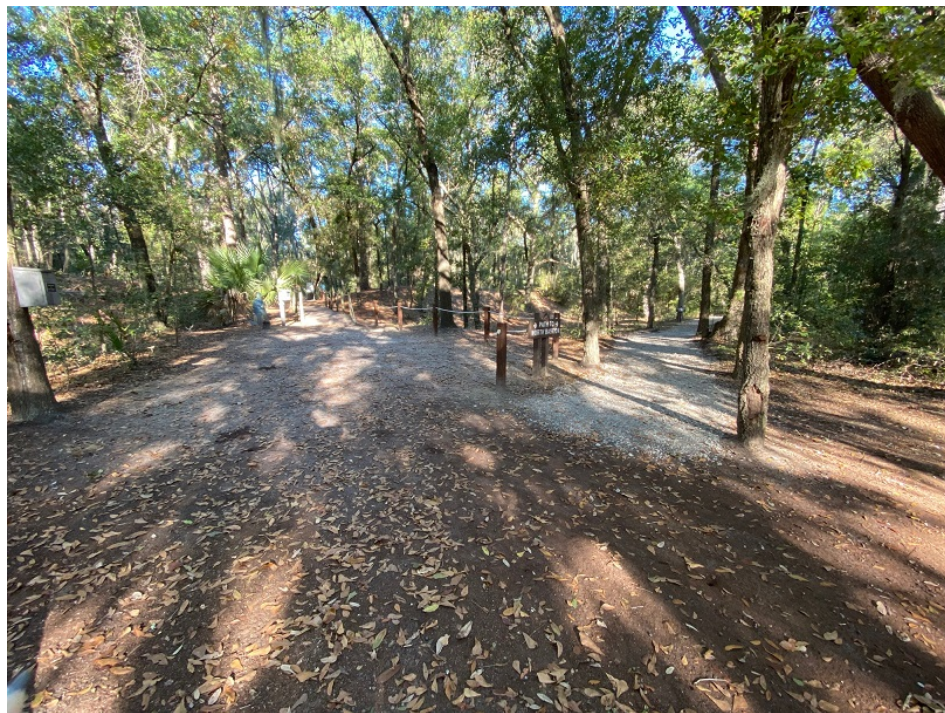
3.4.3 Another path was constructed during the summer of 2020 using funds provided by the TOHHI under an ATAX grant. The surface consists of broken concrete and demolition materials that were laid directly on top of the existing soil, thereby avoiding any disturbance or excavation of the original surface (Photo 8). This is a perimeter path that starts from the bridge and runs partially along the outside of the ditch and then drops into the ditch at the point where there is no available property beyond the outside edge of the ditch. The path runs about halfway around the fort to a point opposite the North Bastion where it now ends. At the end of the trail, it is apparent that some visitors climb up the fort wall, wearing down a path that can be subject to erosion (Photo 10). Continuation of the path completely around the fort would eliminate the desire of visitors to climb up the walls of the fort.

Photo 8. Start of new perimeter path to the right and the path over the bridge to the Fort on the left.

The new path that extends halfway around the outside of the fort needs to be extended to completely circumnavigate the fort. The design and material should be the same as the existing path. This will require removing and thinning the dense vegetation that extends along the west wall of the fort south of the North Bastion. In addition, precautions will have to be made to avoid having foot traffic directly on the toe of the South Bastion where the perimeter wood fence is very close to the toe.

- 4.4.1 Completion of the Perimeter Path - This will involve tracing out a route for the path and having it inspected to assure avoidance of trees forming the canopy. In addition, engineering will be needed to design a structure over the toe of the South Bastion to avoid walking directly on the earthworks. A grant will be sought for this next year (2021) for work to commence in 2022.

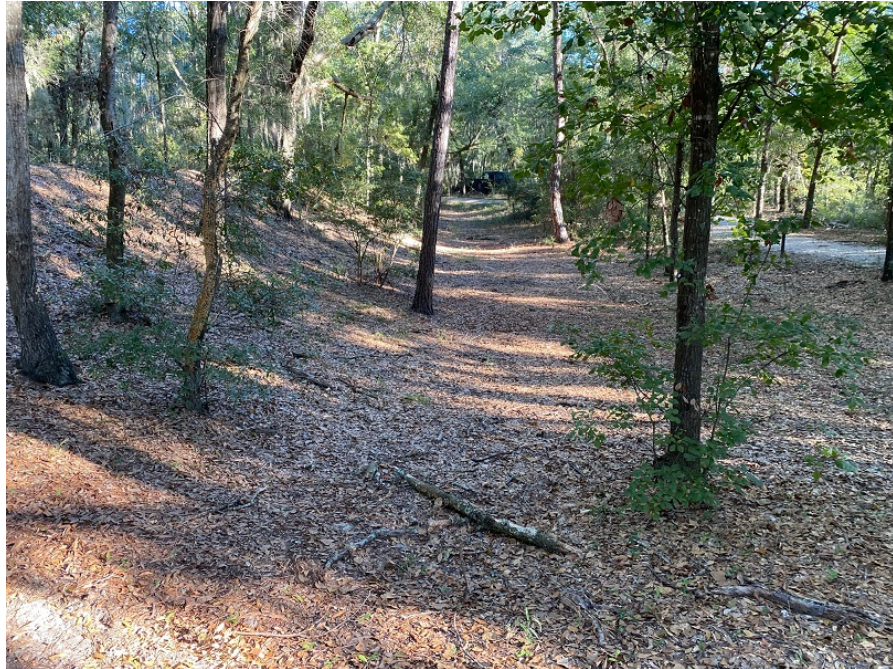
3.5 Ditch Works - Over time the interior and exterior sides of the ditch have eroded to a natural slope (Photo 9). Beyond approximately the northeast salient the perimeter chain link fence, marking the property line with Palmetto Hall, runs at the top edge of the exterior slope of the ditch, leaving no room for the path outside of the ditch. This condition changes at approximately the southwest salient where the perimeter fence and property line drop into the ditch forcing any perimeter path into the ditch. An 8-foot solid wood fence that parallels Beach City Road crosses into the ditch near the South Bastion. Outside this fence, years ago fill was placed in a portion of the ditch for the construction of a paved public walking path and the road (Photo 12).

Photo 9. View of ditch outside the NE wall and the perimeter path to the right.

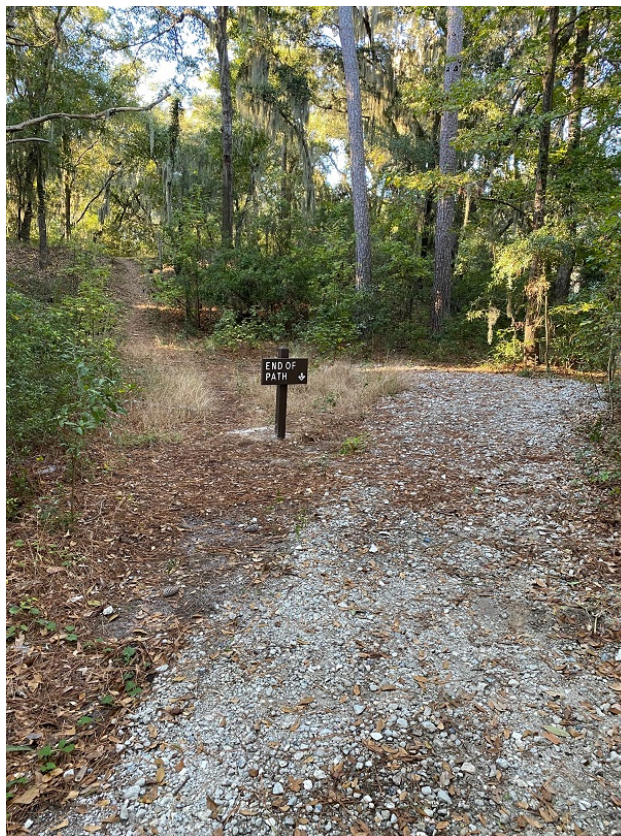
Photo 10. Current end of the perimeter path showing the new path up the wall to the North Bastion.

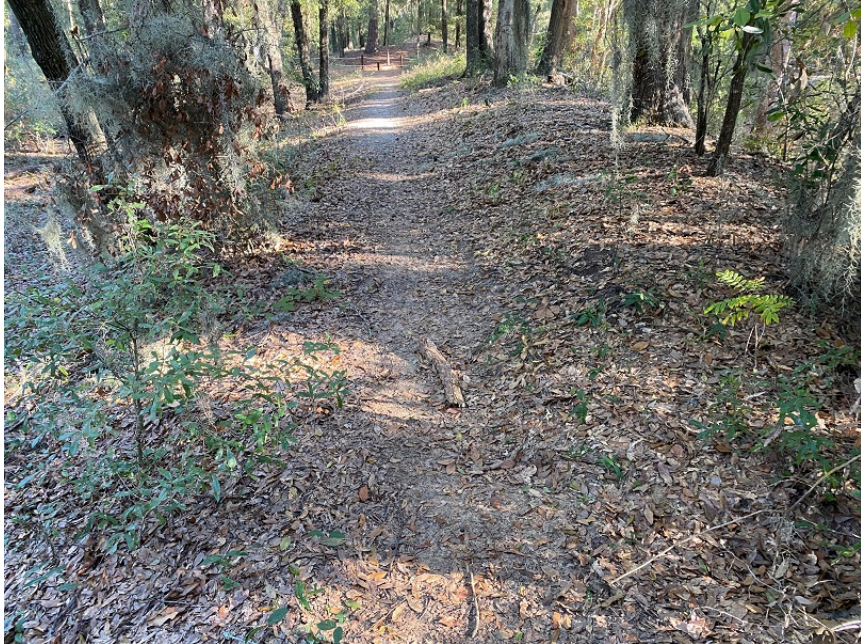
3.4.4 There are additional paths that have been created by visitors who have walked across the fort where dense vegetation allows, particularly along the tops of the walls of the fort. These are all on original soils and create the potential for erosion (Photo 11).

Photo 11. Path worn by visitors along the top of the SE wall.

4.2.2 There are a number of paths through and around the fort, primarily along the tops of the walls, that threaten its stability and integrity and can lead to erosion. Many of these paths should be blocked from public use or improved to withstand such use. Paths should be clearly marked and

if necessary, those not approved should be also marked by signage as not for access.

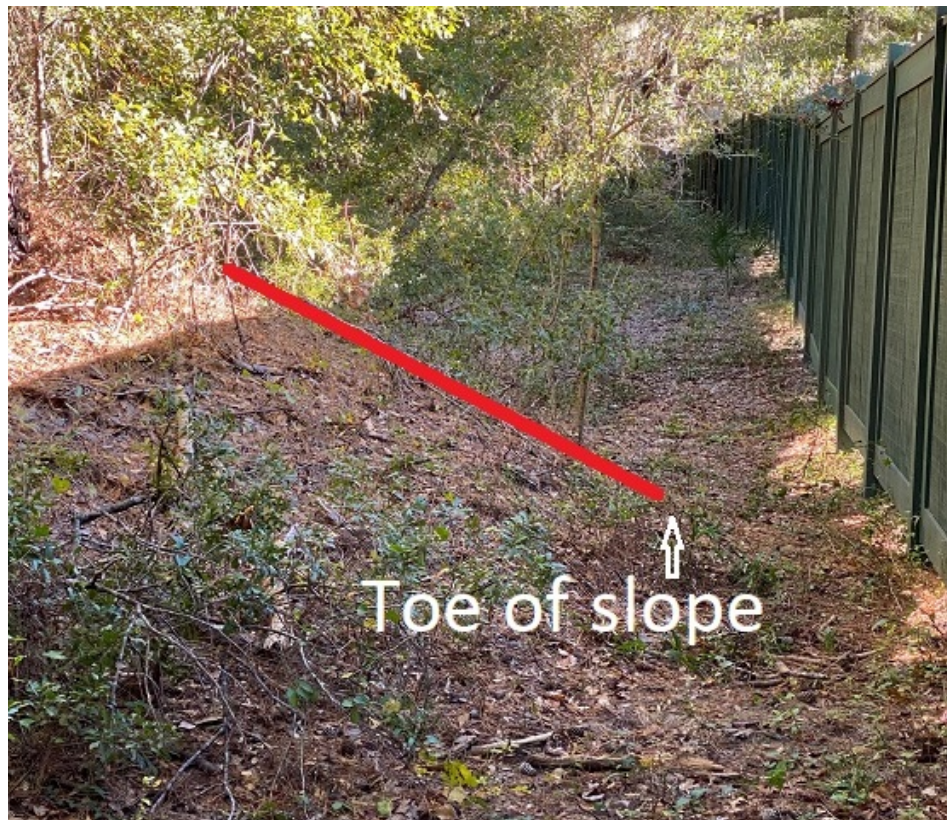
Photo 12. The approach of the toe of the South Bastion to the barrier fence.
